**Flood Control Project Maintenance
Levee Inspections**

Fall 2010 Levee Maintenance Deficiency Summary Report

Reclamation District No. 2063 Crows Landing

Levee Inspection Report By Mile - Fall 2010

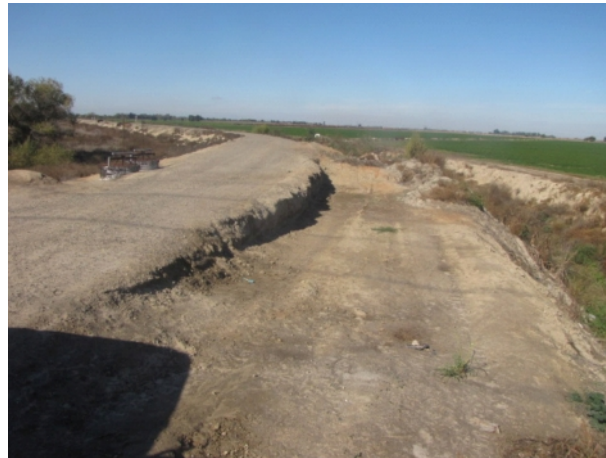
Levee Mile Report Line	5
Start Levee Mile	1.35
End Levee Mile	1.35
Location	Land Side
Category	Earthen Levee
Item	Encroachments

5	1.35	1.35	Earthen Levee	Encroachments	LS	PO	Ramp Inspector Comments: Ramp does not meet CVFPB standards. Ramp has 18-20" vertical cut at landside shoulder.	37.464308 ° -121.032603 °	37.464308 ° -121.032603 °	6 Y
6	1.39	1.39	Earthen Levee	Animal Control	LS	A	No rodents visible, but rodent burrows visible; need to backfill and compact or grout borrows.	37.463875 ° -121.032355 °	37.463875 ° -121.032355 °	971
7	1.47	1.50	Earthen Levee	Vegetation	LS	M	Remove the wild growth other than native grasses from the levee slopes.	37.462723 ° -121.032020 °	37.462303 ° -121.031928 °	8
8	1.54	1.54	Earthen Levee	Slope Stability	LS	M	Repair the levee slope damaged by vehicle traffic and prevent access where possible.	37.461762 ° -121.031822 °	37.461762 ° -121.031822 °	10 Y
9	1.57	1.57	Earthen Levee	Animal Control	LS	M	Exterminate rodents and backfill and compact or grout burrows.	37.461322 ° -121.031785 °	37.461322 ° -121.031785 °	4

Looking north at ramp and equipment working pad on landside slope with a 18-20" vertical cut at shoulder.

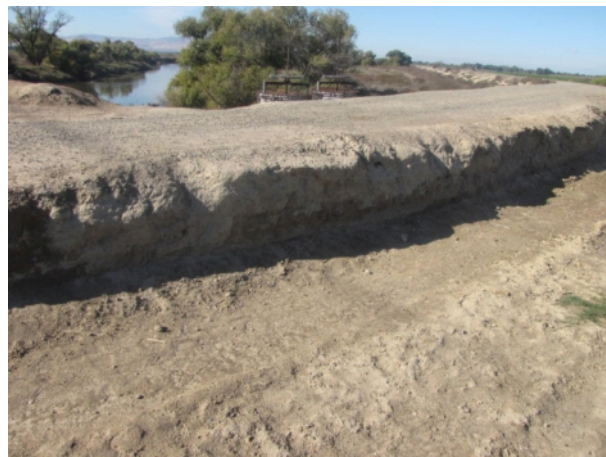
Levee Mile Report Line	5
Start Levee Mile	1.35
End Levee Mile	1.35
Location	Land Side
Category	Earthen Levee
Item	Encroachments

Looking west at 18-20" vertical cut for ramp on landside shoulder and slope

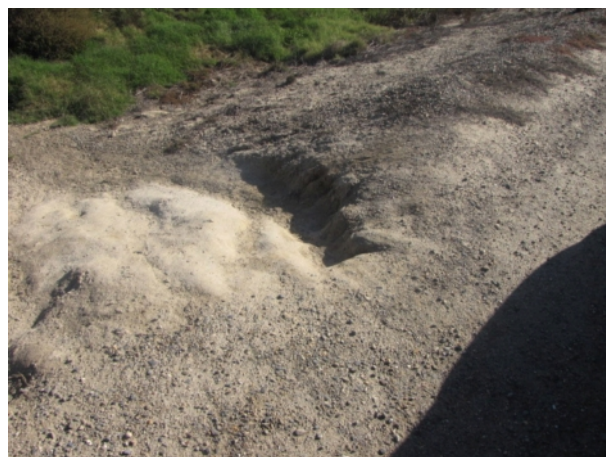
Levee Mile Report Line	8
Start Levee Mile	1.54
End Levee Mile	1.54
Location	Land Side
Category	Earthen Levee
Item	Slope Stability

Looking east at landside slope damage (six to eight inch erosion) by vehicle

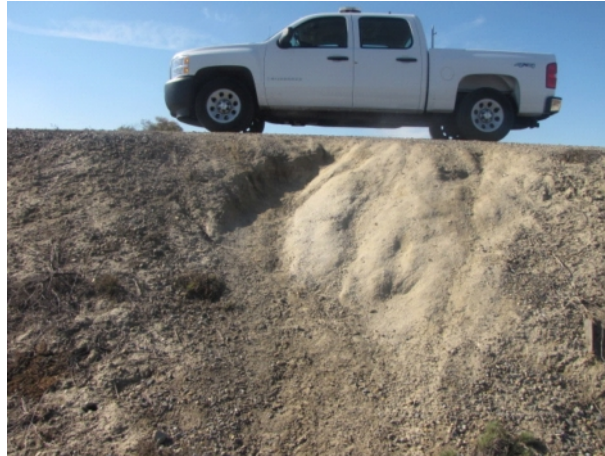
Levee Mile Report Line	8
Start Levee Mile	1.54
End Levee Mile	1.54
Location	Land Side
Category	Earthen Levee
Item	Slope Stability

Looking west at landside slope damage cause by vehicle traffic.

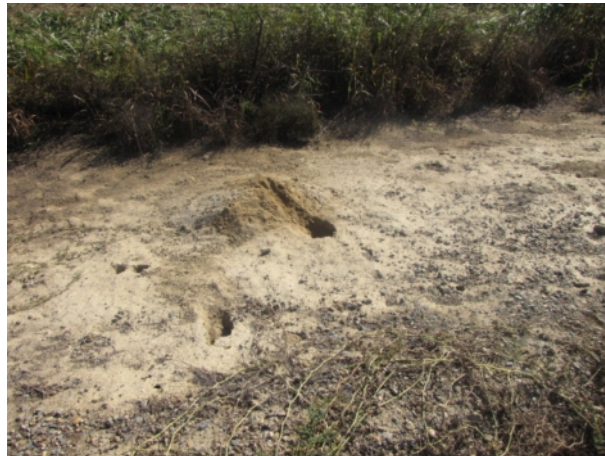
Levee Mile Report Line	10
Start Levee Mile	1.69
End Levee Mile	1.69
Location	Land Side
Category	Earthen Levee
Item	Animal Control

10	1.69	1.69	Earthen Levee	Animal Control	LS	M	No rodents visible, but rodent burrows visible; need to backfill and compact or grout borrows.	37.459813 ° -121.032372 °	37.459813 ° -121.032372 °	11 Y
11	2.09	2.09	Earthen Levee	Trim / Thin Trees	LS	C	Trim trees to at least five feet above ground level.	37.454593 ° -121.032530 °	37.454593 ° -121.032530 °	972
12	2.31	2.47	Earthen Levee	Erosion / Bank Caving	LS	U	Schedule repair of erosion site prior to the next inspection. Inspector Comments: Erosion is accruing around 10-12 inch concrete irrigation pipe at landside toe.	37.451927 ° -121.030555 °	37.450290 ° -121.028592 °	12 Y
13	2.56	2.56	Earthen Levee	Vegetation	LS	M	Remove the wild growth other than native grasses from the levee slopes.	37.449432 ° -121.027472 °	37.449432 ° -121.027472 °	13
14	2.72	2.72	Supplemental	DWR Erosion Survey	WS	C	Inspector Comments: 10/20/2010: Site has been repaired by the district. Site was previously rated "M". 08/06/2010: Recommended as local maintenance issue, per CLRO. [2010 SiteID: RD2063U01RM105.5]	37.447450 ° -121.026090 °	37.447450 ° -121.026090 °	1

Looking east at squirrel holes on landside slope.

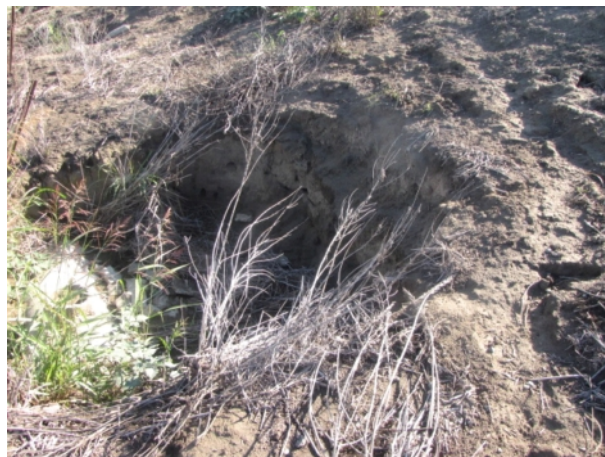
Levee Mile Report Line	12
Start Levee Mile	2.31
End Levee Mile	2.47
Location	Land Side
Category	Earthen Levee
Item	Erosion / Bank Caving

Looking west at slope caving around concrete irrigation pipe on landside toe.

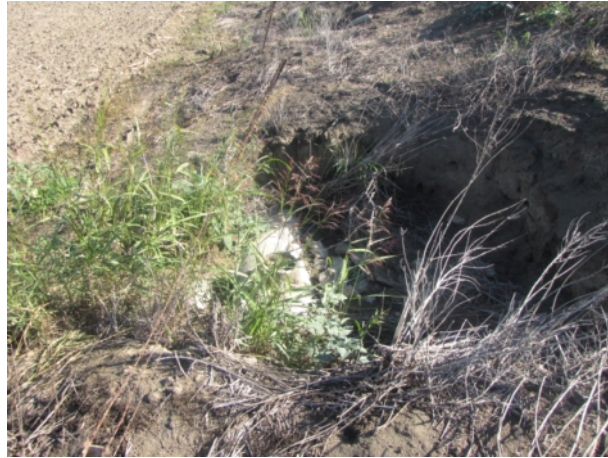
Levee Mile Report Line	12
Start Levee Mile	2.31
End Levee Mile	2.47
Location	Land Side
Category	Earthen Levee
Item	Erosion / Bank Caving

Looking south at additional caving around concrete pipe.

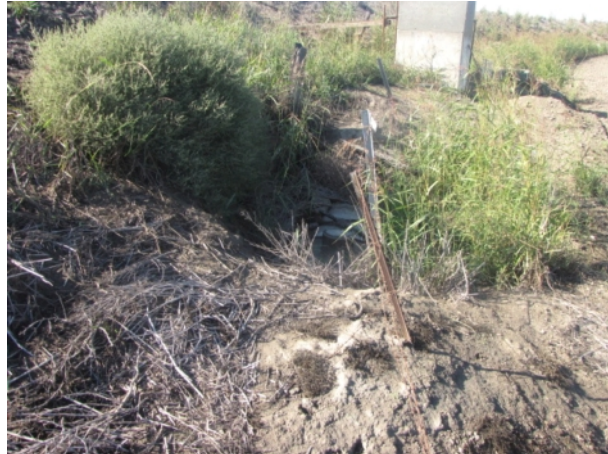
Levee Mile Report Line	12
Start Levee Mile	2.31
End Levee Mile	2.47
Location	Land Side
Category	Earthen Levee
Item	Erosion / Bank Caving

Looking north at site #1 caving around pipe on landside slope.

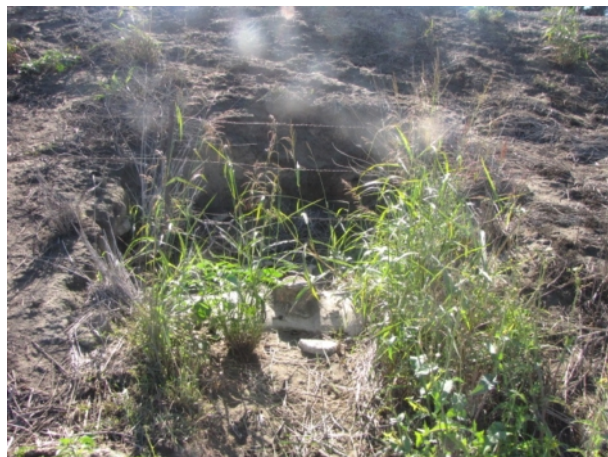
Levee Mile Report Line	12
Start Levee Mile	2.31
End Levee Mile	2.47
Location	Land Side
Category	Earthen Levee
Item	Erosion / Bank Caving

Looking west at caving around concrete pipe at site #3.

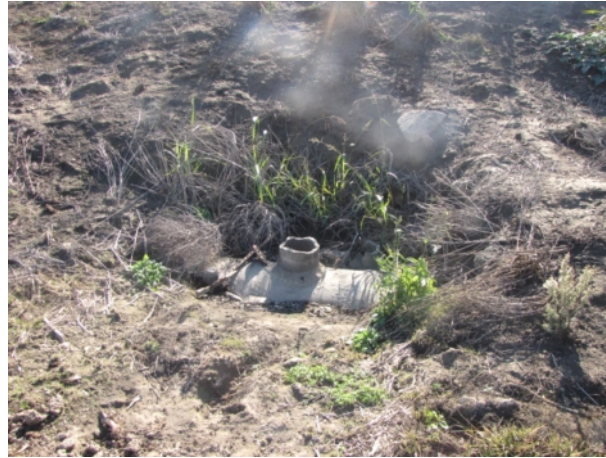
Levee Mile Report Line	12
Start Levee Mile	2.31
End Levee Mile	2.47
Location	Land Side
Category	Earthen Levee
Item	Erosion / Bank Caving

Looking west at concrete irrigation pipe that runs along landside toe.

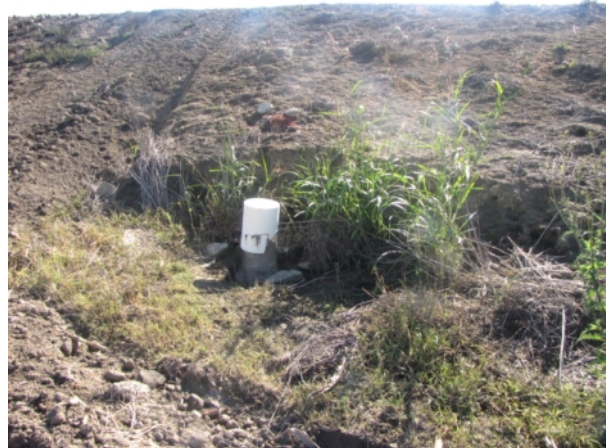
Levee Mile Report Line	12
Start Levee Mile	2.31
End Levee Mile	2.47
Location	Land Side
Category	Earthen Levee
Item	Erosion / Bank Caving

Looking southwest at site # 4 of slope caving around concrete irrigation pipe at landside toe.

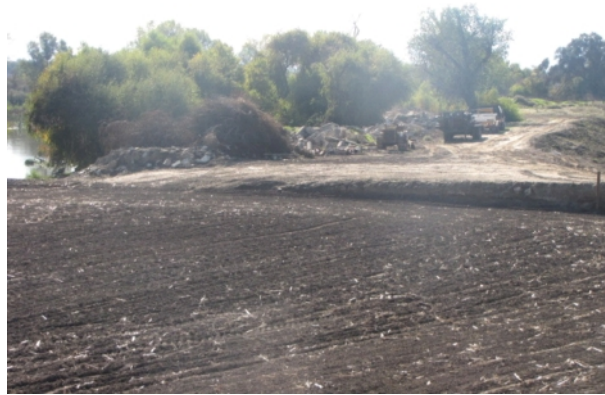
Levee Mile Report Line	21
Start Levee Mile	4.53
End Levee Mile	4.53
Location	Water Side
Category	Channels
Item	Encroachments

Looking northwest at garbage in channel.

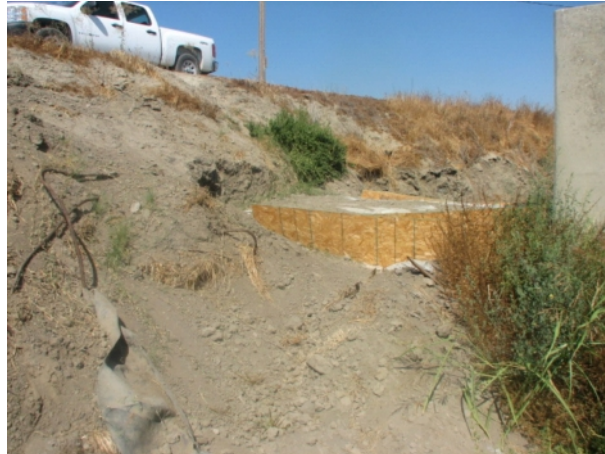
Levee Mile Report Line	25
Start Levee Mile	5.13
End Levee Mile	5.13
Location	Land Side
Category	Earthen Levee
Item	Encroachments

View of cut into landside slope

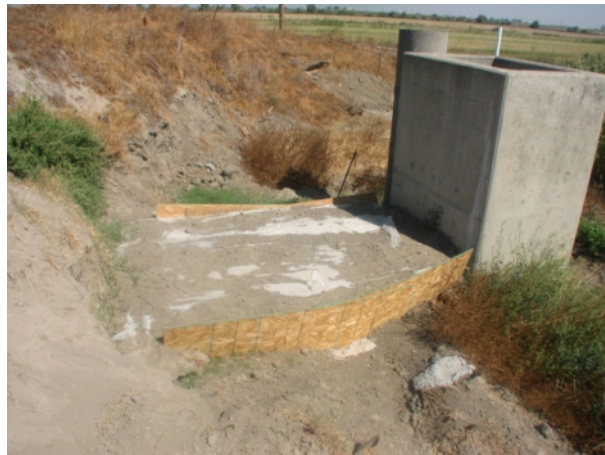
Levee Mile Report Line	25
Start Levee Mile	5.13
End Levee Mile	5.13
Location	Land Side
Category	Earthen Levee
Item	Encroachments

View of concrete stand pipe and encased pipe on landside toe.
